Yampa River Scorecard Project Upper Yampa Segment Results and Scoring

March 2025

Friends of the Yampa
Steamboat Springs, Colorado

Alba Watershed Consulting
Boulder, Colorado

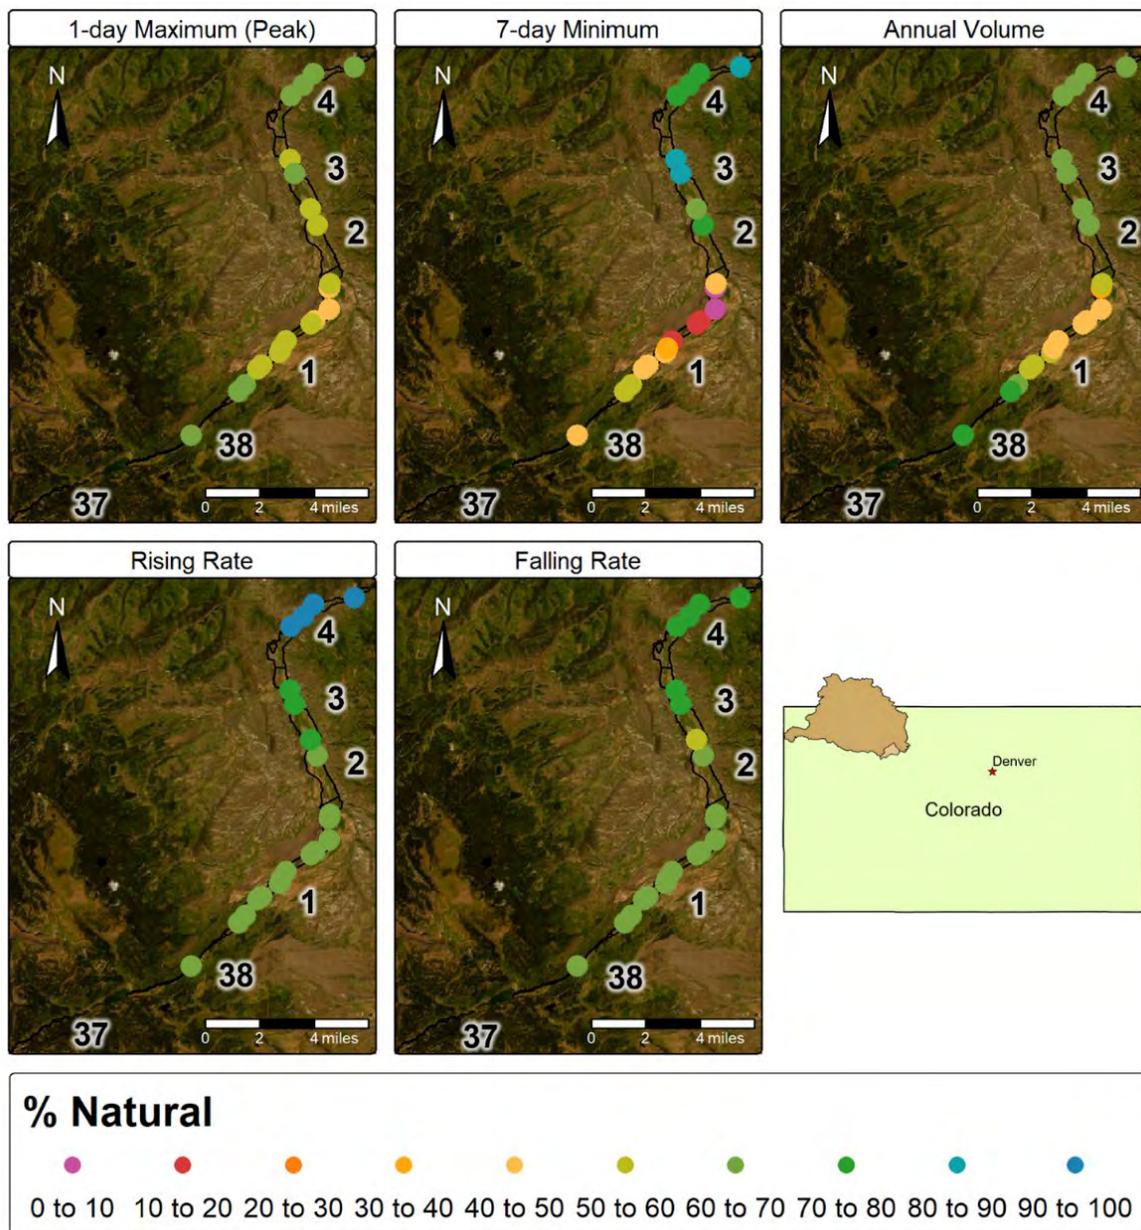
Figure 2-2. Percent of Natural Flow Characteristics for Hydrograph Sub-Indicators at Upper Yampa Modeling Nodes

Percent of natural annual 1-day maximum flows is a metric that reflects the degree to which the magnitude of high flow events has changed from modeled natural flows during the period of record studied (1975-2013, Lotic 2021, Mason 2021). In all riverscapes in which analysis was possible (riverscapes 38, 1-4), modeled results indicate that average percent of natural conditions for the 1-day maximum flow per riverscape ranged from 54 to 67% of modeled natural flows (Figure 2-2). The departure from modeled natural high flows indicates a high density of diversions and instream infrastructure, regulated reservoirs, or other anthropogenic influences (Yampa IWMP 2022). No modeling results are reported for riverscape 37 due to the lack of modeling nodes (i.e., the points of the river at which flows are simulated) in these riverscapes.

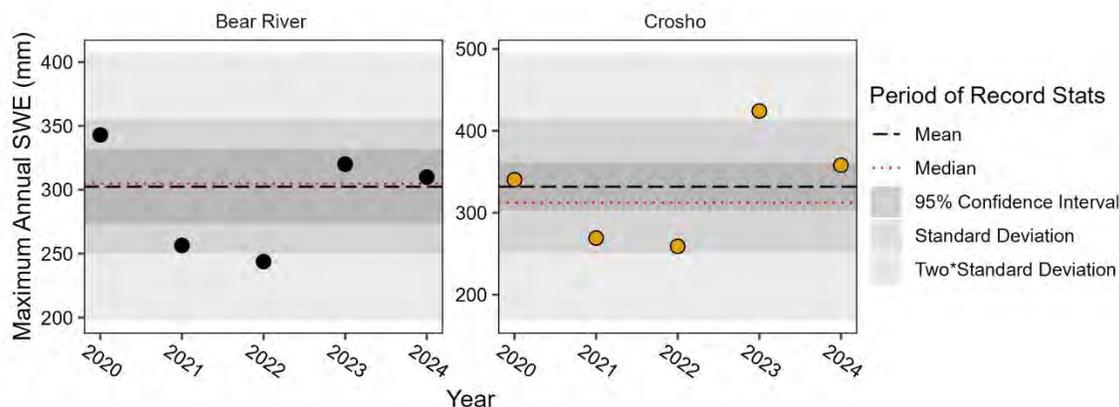
Figure 2-6. Maximum Annual SWE Volume (2020-2024) Compared to Long-Term Data

Figure 2-6 compares the maximum annual SWE volume for the past 5 years of data (2020-2024) to the long-term mean (dashed line), 95% confidence interval (dark gray), and standard deviation (medium gray) generated from the period of record data. Maximum SWE volume over the last five years is generally within a single standard deviation of the period of record mean (Figure 2-6). For the current water year (2023-2024), the maximum annual SWE lies closely to the mean value for each of the SNOTEL stations, within the 95% confidence interval (Figure 2-6). In 2021 and 2022, SWE volume is significantly below the mean (i.e., outside the 95% confidence interval) at each SNOTEL station, though still within a single standard deviation of the mean at the Crosho station (2022 at Bear River is the exception). At Crosho, the maximum annual SWE was

significantly higher than the mean and greater than one standard deviation from the mean (Figure 2-6), implying a direct beneficial impact to the Yampa River. Compared to the winter of 2023, however, the winter of 2024 presented less SWE with insignificant differences from the historical mean for each SNOTEL station (Figure 2-5). Scores for maximum SWE for the 5-year period of record are found in Table 2-4.

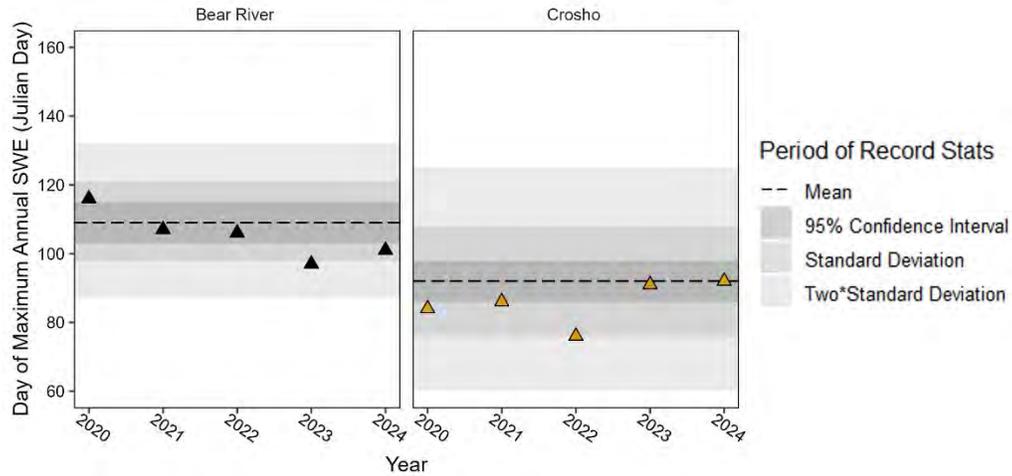
Figure 2-7. Timing of Maximum Annual SWE Volume (2020-2024) Compared to Long-Term Data

Figure 2-7 shows the timing of maximum annual SWE volume (day of year) for the past five years of data compared to the long-term mean (dashed line), 95% confidence interval (dark gray), and standard deviation (medium gray) generated from the period of record data. All datapoints analyzed indicated that maximum annual SWE occurred earlier than the historical mean, except during the winter of 2020 at the Bear River SNOTEL site. At each SNOTEL site, the timing of maximum annual SWE is within a single standard deviation of the mean for all years (Figure 2-7). During the winter of 2024, the Crosho site experienced a similar timing of maximum annual SWE to the historical mean, at approximately 90 Julian Days (March 31, Figure 2-7). The maximum annual SWE came significantly sooner than the historical mean at the Bear River site during the winter of 2024, but the timing still fell within one standard deviation (Figure 2-7). Timing scores are reported in Table 2-5.

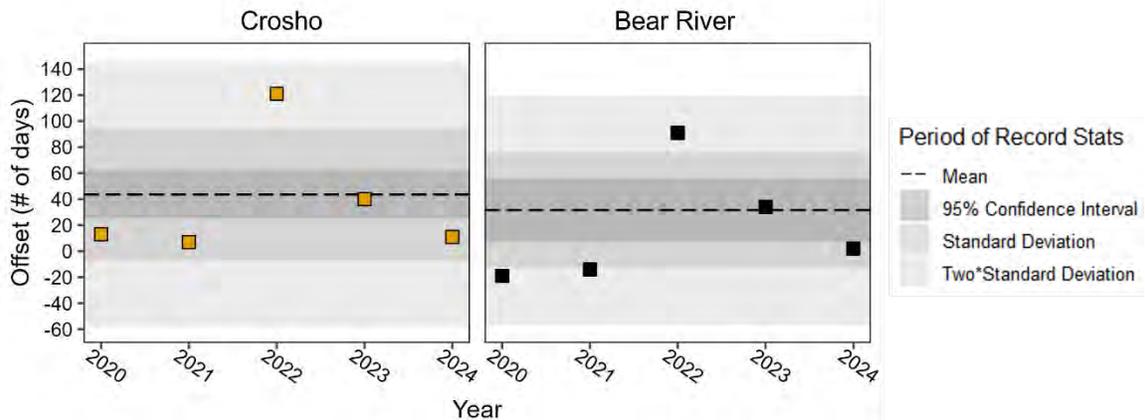
Figure 2-8. Offset of Maximum Annual SWE Volume and Peak River Discharge (2020-2024) Compared to Long-Term Data

Finally, the length of time (i.e., offset) between the timing of peak SWE from the Crosho and Bear River SNOTEL stations and the timing of peak streamflow from the USGS Yampa River Above Stagecoach station are shown in Figure 2-8. In general, the two SNOTEL stations had similar trends in offset, likely because the SNOTEL stations are situated approximately 10 miles from one another and have similar timings for peak SWE over the last five years. At the Bear River station, however, offset was negative in 2020 and 2021 which indicates the length of time between peak snowpack and peak streamflow was shorter than the mean length of time between these two events (Figure 2-8). The offset was highest in 2022 for both SNOTEL stations, when peak streamflow occurred 121 days after peak SWE for Crosho and 91 days after peak SWE for Bear River (Figure 2-8). These values were both significantly higher than the long-term mean for each station, and likely signifies an earlier than usual snowmelt onset coupled with a delayed peak river discharge. The year 2022 also had lower than average maximum annual SWE (Figure 2-6) suggesting lower-than-usual snow accumulation. The long-term mean for offset suggests peak streamflow normally occurs around 30 or 40 days after peak SWE for the Bear River and Crosho stations, respectively (Figure 2-8). Although the maximum annual SWE was slightly higher than the long-term mean in 2024 (Figure 2-6), the offset is significantly low at both SNOTEL stations, suggesting the peak SWE and peak streamflow occurred at relatively similar timings. The

combined effect of reduced snowpack and early snowmelt can disrupt the usual hydrological dynamics. Scores for this indicator are found in Table 2-5.

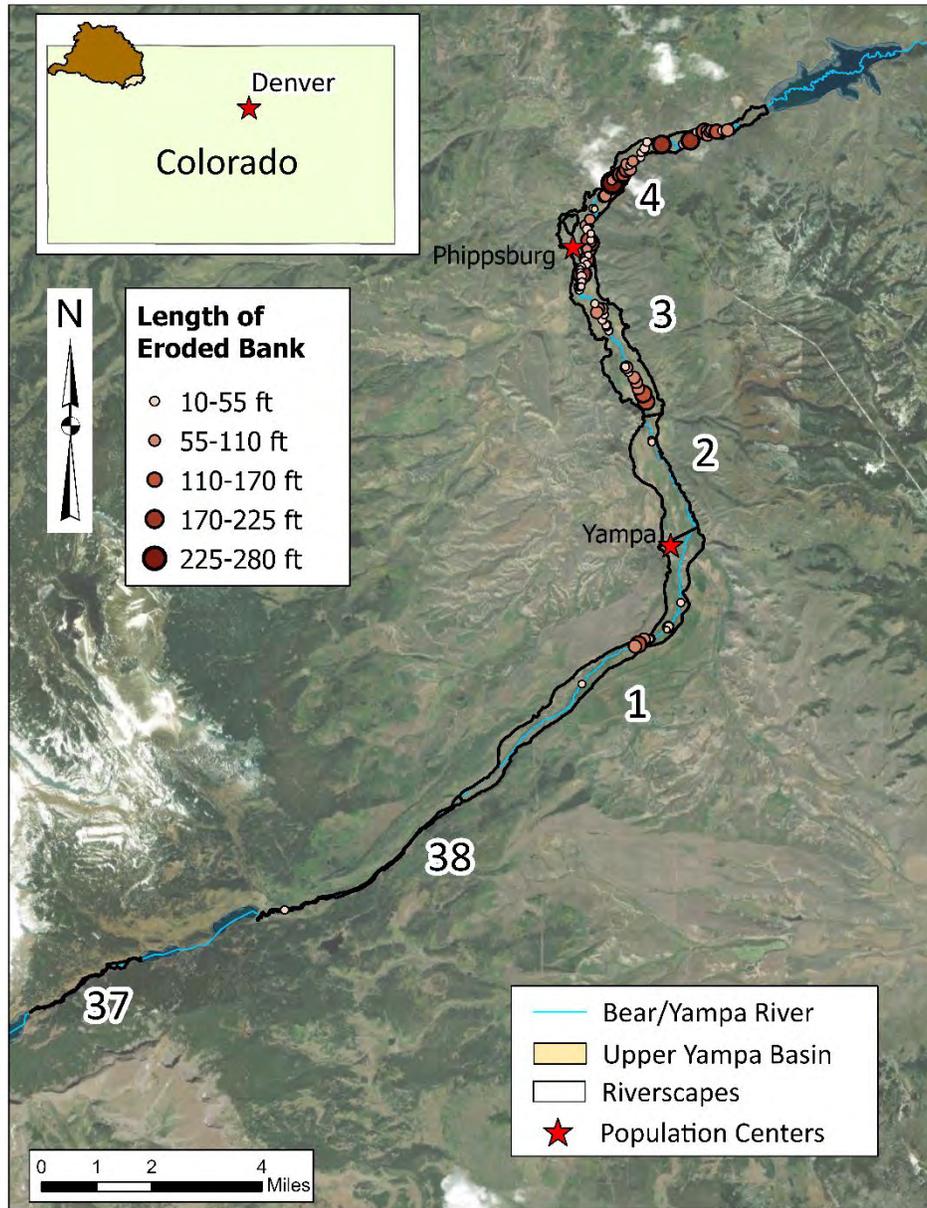
Figure 3-1. Distribution and Amount of Bank Erosion in the Upper Yampa Segment

Examination of field-collected data reveals that bank erosion increases downstream, with minimal erosion in riverscapes 37 and 38, and a much higher degree of erosion in riverscape 4 (Figure 3-1). Bank erosion is more commonly found in the downstream riverscapes (1-4) because the channel is more sinuous and meander bend cutbanks are capable of eroding. Although this could be a possible sediment imbalance in the downstream riverscapes, cutbank erosion is a natural and expected pattern in a healthy river system.

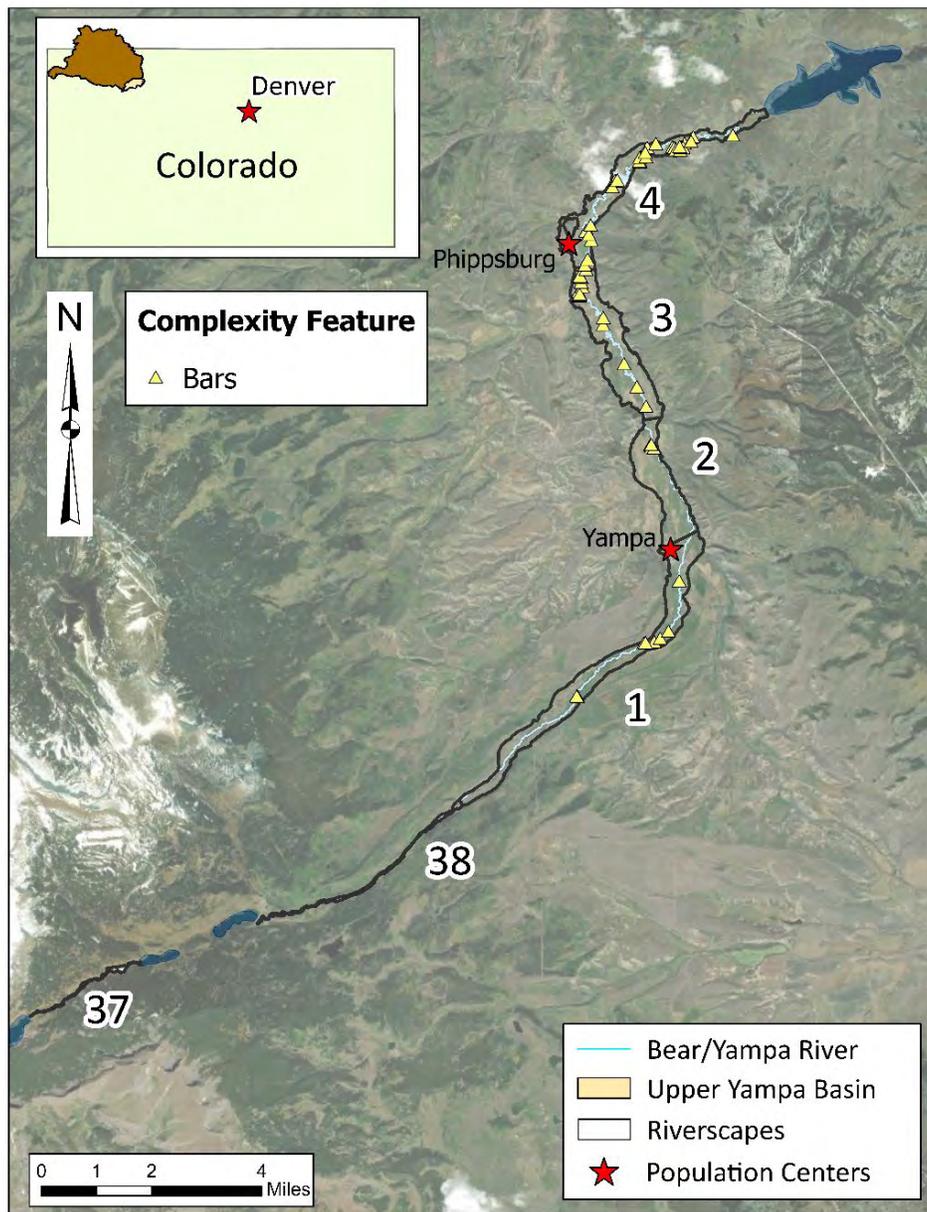
Figure 3-2. Locations of Bar Features by Riverscape

Deposition and erosion are natural processes that play a key role in shaping rivers and maintaining their health, and a balance of these processes is crucial to creating and sustaining various habitats and features including meanders, bars, pools, riffles, and floodplains. In excess, however, erosion can lead to rapid bank collapse, channel incision, and loss of floodplain connectivity. Generally, where bank erosion was most present (riverscapes 1-4), these phenomena were not observed. Suspended sediment concentrations were elevated, however, compared to USGS gauges downstream of Stagecoach Reservoir (Day 2021), and degree of embeddedness increased in a downstream direction (Figure 9-4). These observations could be attributed to increased sediment erosion from local grazing practices. Sediment transport and continuity scores for all riverscapes are provided in Table 3-2.

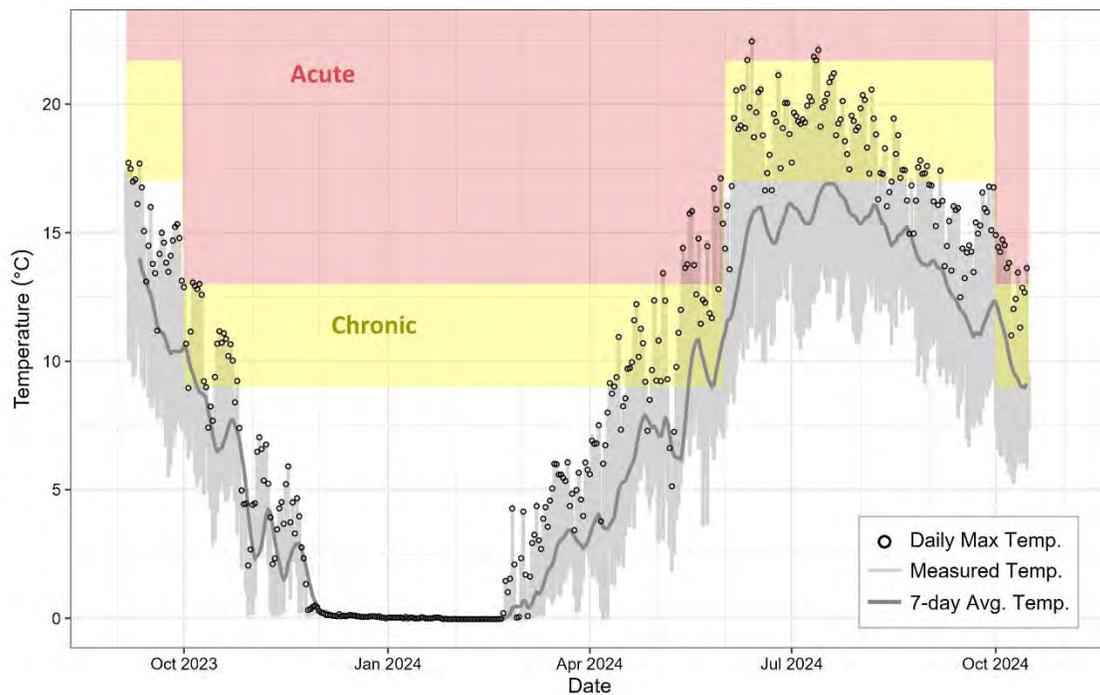
Figure 4-2. Temperature Data from HOBO Logger Near Phippsburg

Based on the data analyzed and in accordance with the scoring criteria, riverscapes 3 and 4 earned a score of C+ (Table 4-4). Regulatory standards were occasionally exceeded, but the riverscapes are not located within a river reach on the CDPHE Monitoring and Evaluation list. Riverscapes 37, 38, and 1 are located upstream of the Town of Yampa on the Bear River, and riverscape 2 is located on the Yampa River between Yampa and Phippsburg. These riverscapes were given a score

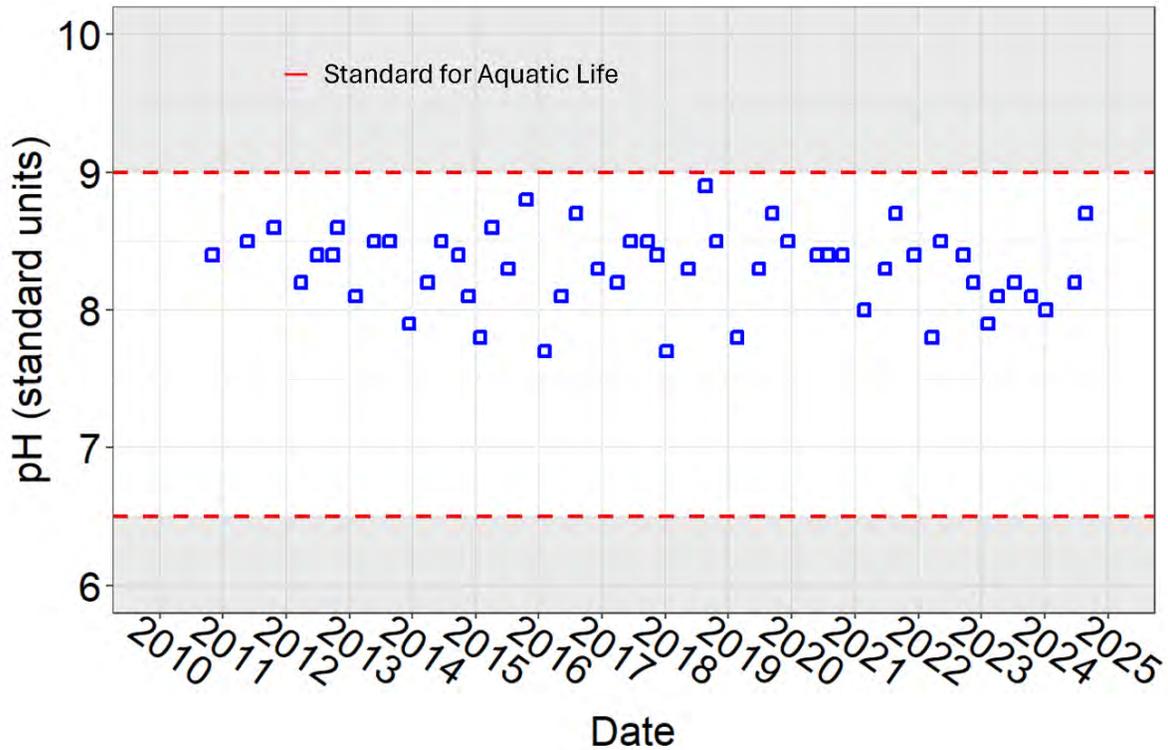
Figure 4-5. pH Values from Quarterly Water Sampling at USGS Gauge Yampa Above Stagecoach (2010-2024)

score the pH indicator (Table 4-7). pH values do not fall outside the range of regulatory standards for aquatic life (Figure 4-5). Regulatory standards are regularly and consistently met. Values of pH across the Upper Yampa segment indicate slightly alkaline conditions, with pH values generally ranging from 7.5 to 9 from 2010 to 2024 (Figure 4-5). Instantaneous pH measurements taken in riverscapes 38 and 2 (Table 4-1) also fall within the range of regulatory standards. All riverscapes received an A score (Table 4-8).

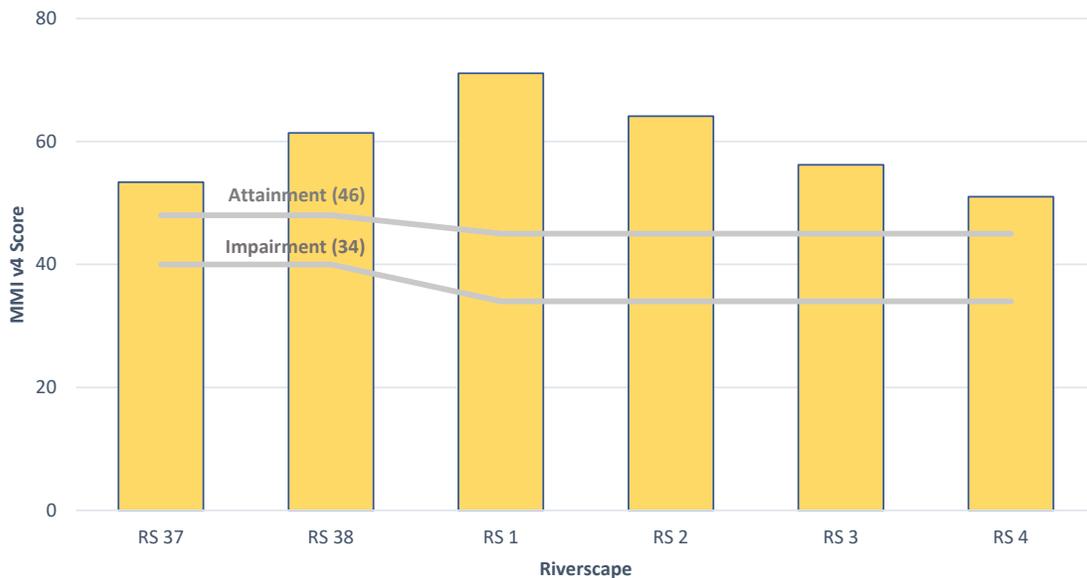
Figure 4-6. Macroinvertebrate MMI Scores by Riverscape

The statistics from riverscape 4 illustrate some of the impacts that agriculture can have on macroinvertebrate communities. The HBI score is the only one that is higher than the HBI threshold of 4.9, indicating that the proportion of nutrient-tolerant individuals is elevated. This site also has the lowest MMI score, as well as a relatively low number of EPT taxa. The proportion

Overall, Upper Yampa segment riverscapes received scores between B and C for the macroinvertebrate indicator (Table 4-12). While the riverscapes with lower scores are still in attainment of the aquatic life use per CDPHE guidelines, there is room for improvement for these benthic populations to become more robust and healthier in the future and opportunities for limited management, particularly related to grazing and fertilizer application, to help improve conditions at these locations.

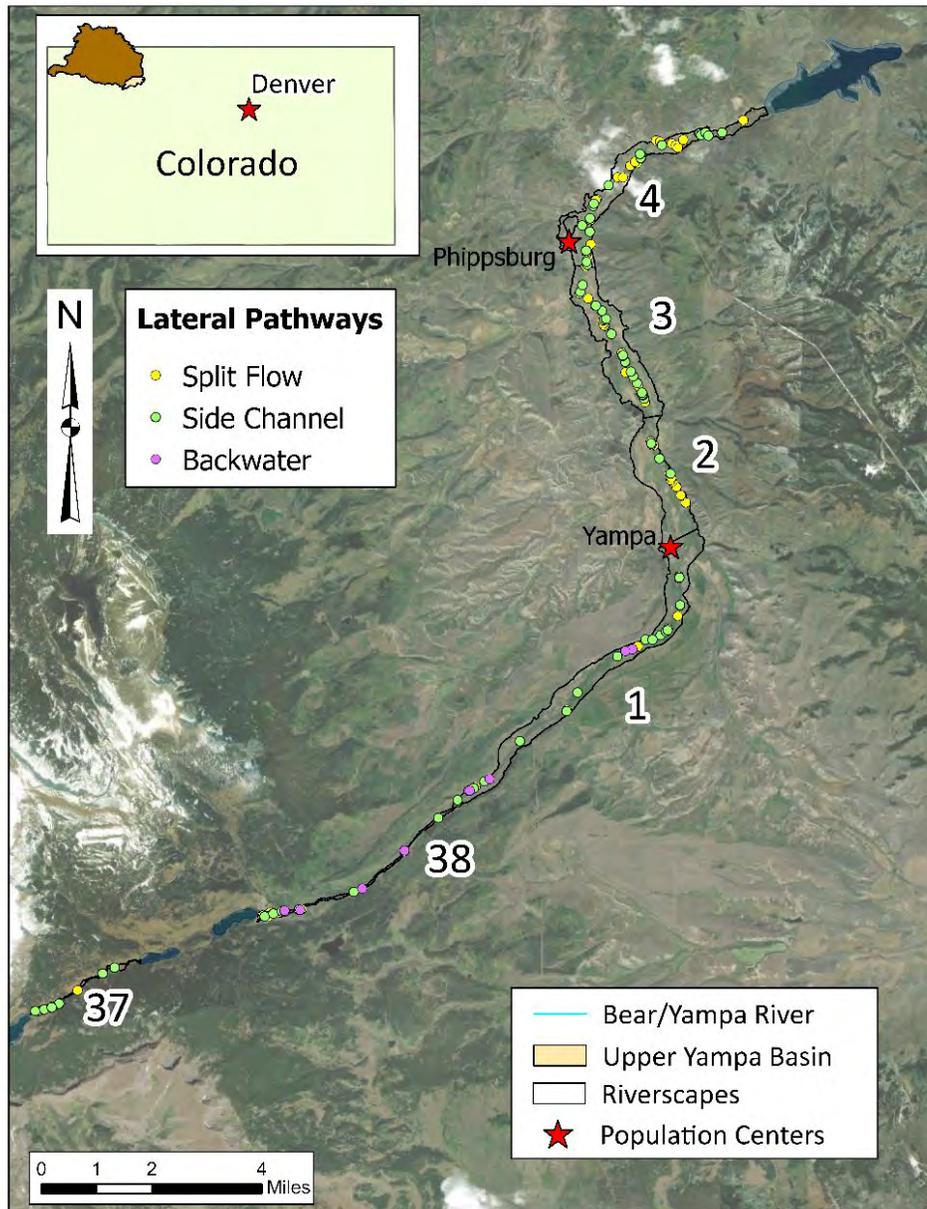
Figure 5-2. Locations of Pathways for Lateral Movement as Observed in the Field

There were approximately 3.2 lateral pathways per mile in riverscape 1 (Figure 5-2). As previously mentioned, however, baseflows are highly altered on a daily basis for almost half the year particularly in riverscape 1 due to calls for water diversions. With less water in the channel, the assumption can be made that lateral pathways will also be affected. Although riverscape 1 has a mild loss of side channel access based on the number of pathways per mile, riverscape 1 receives a C for the lateral pathways score due to the likely substantial loss of pathways from severe changes in baseflow (Table 5-2).

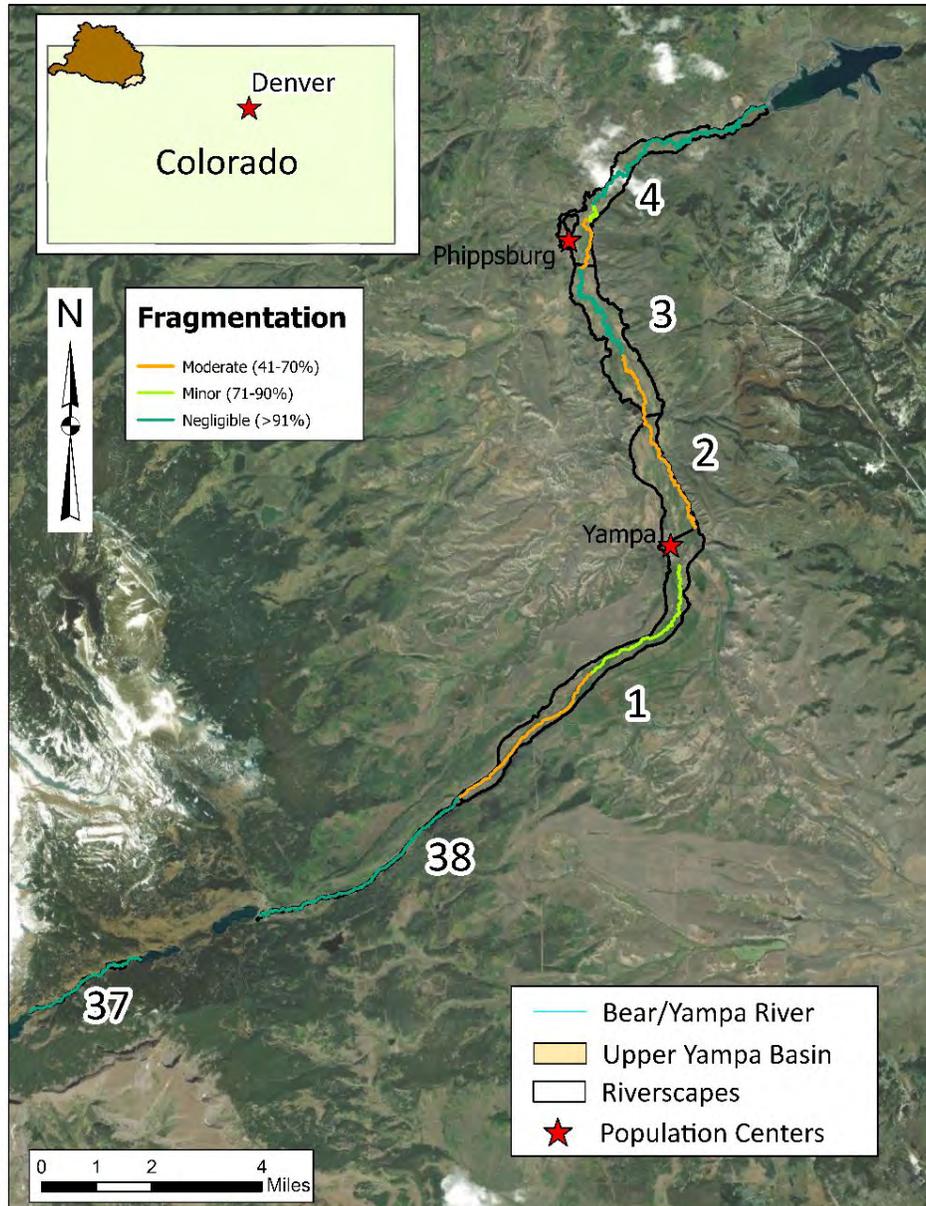
Figure 5-3. Floodplain Fragmentation (Representing Terrestrial Connectivity) by Riverscape

Floodplain fragmentation is moderate in riverscape 3 (Table 5-4), likely due to the presence of Highway 131 and the rail line that both run on the eastern side of the river for the entire length of the riverscape. Lastly, floodplain fragmentation is the highest in riverscape 2, but still moderately fragmented (Table 5-4). Highway 131 and the rail line are located on the western side of the river in this riverscape, intersect the channel near the downstream end, and then are found on the eastern side of the river (Figure 5-3). Because the floodplain fragmentation data are based on major roads, highways, and railroads, fragmentation is relatively high in riverscape 2. This indicator does not include floodplain connectivity, riparian condition, or longitudinal connectivity;

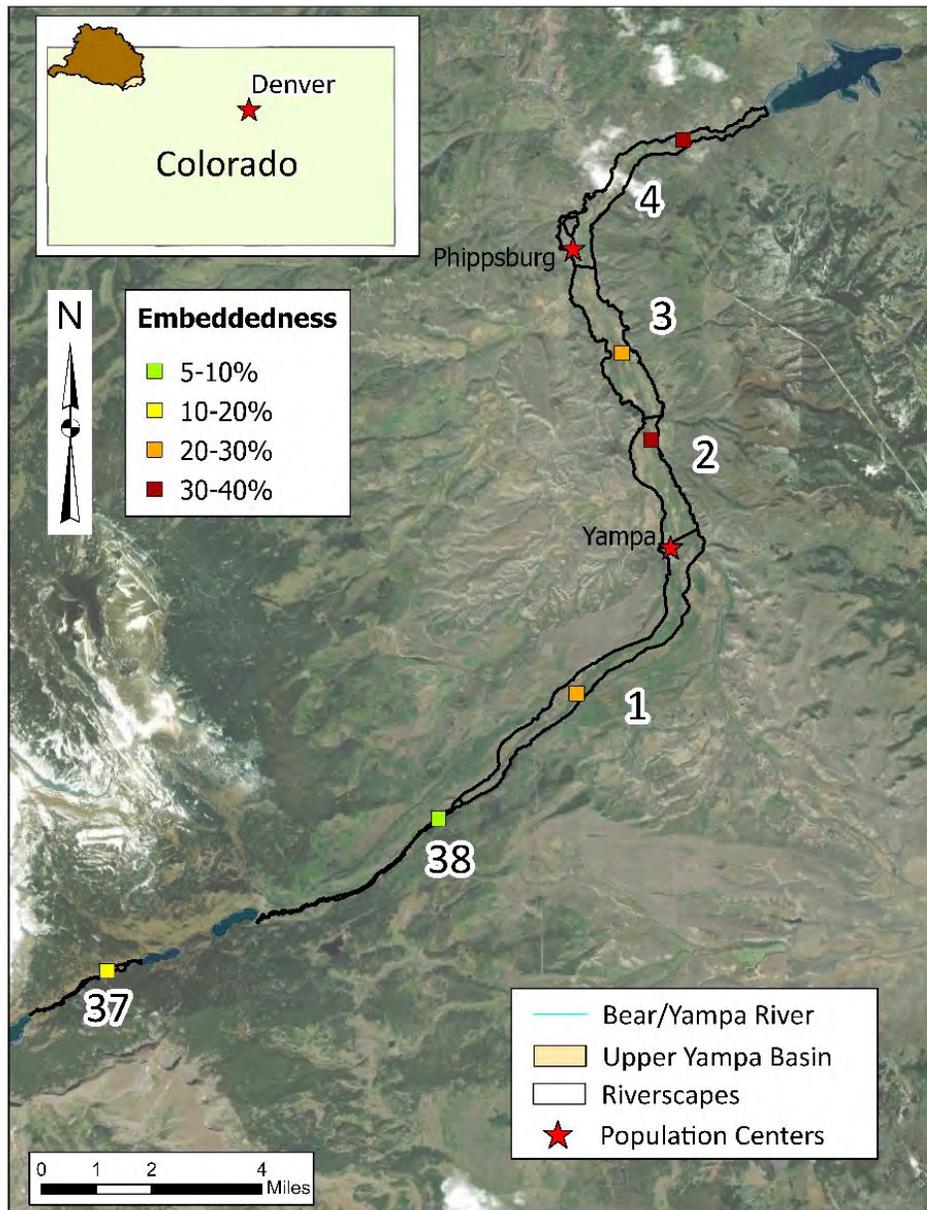
Figure 9-4. Embeddedness Locations and Ranges by Riverscape

Overall, values of embeddedness were within the range of expected variability (from mild to severe), and these percentages indicate an impacted relationship between deposition and transport through some of the lower reaches of the Upper Yampa segment. Scores for the microhabitat indicator are presented in Table 9-4.

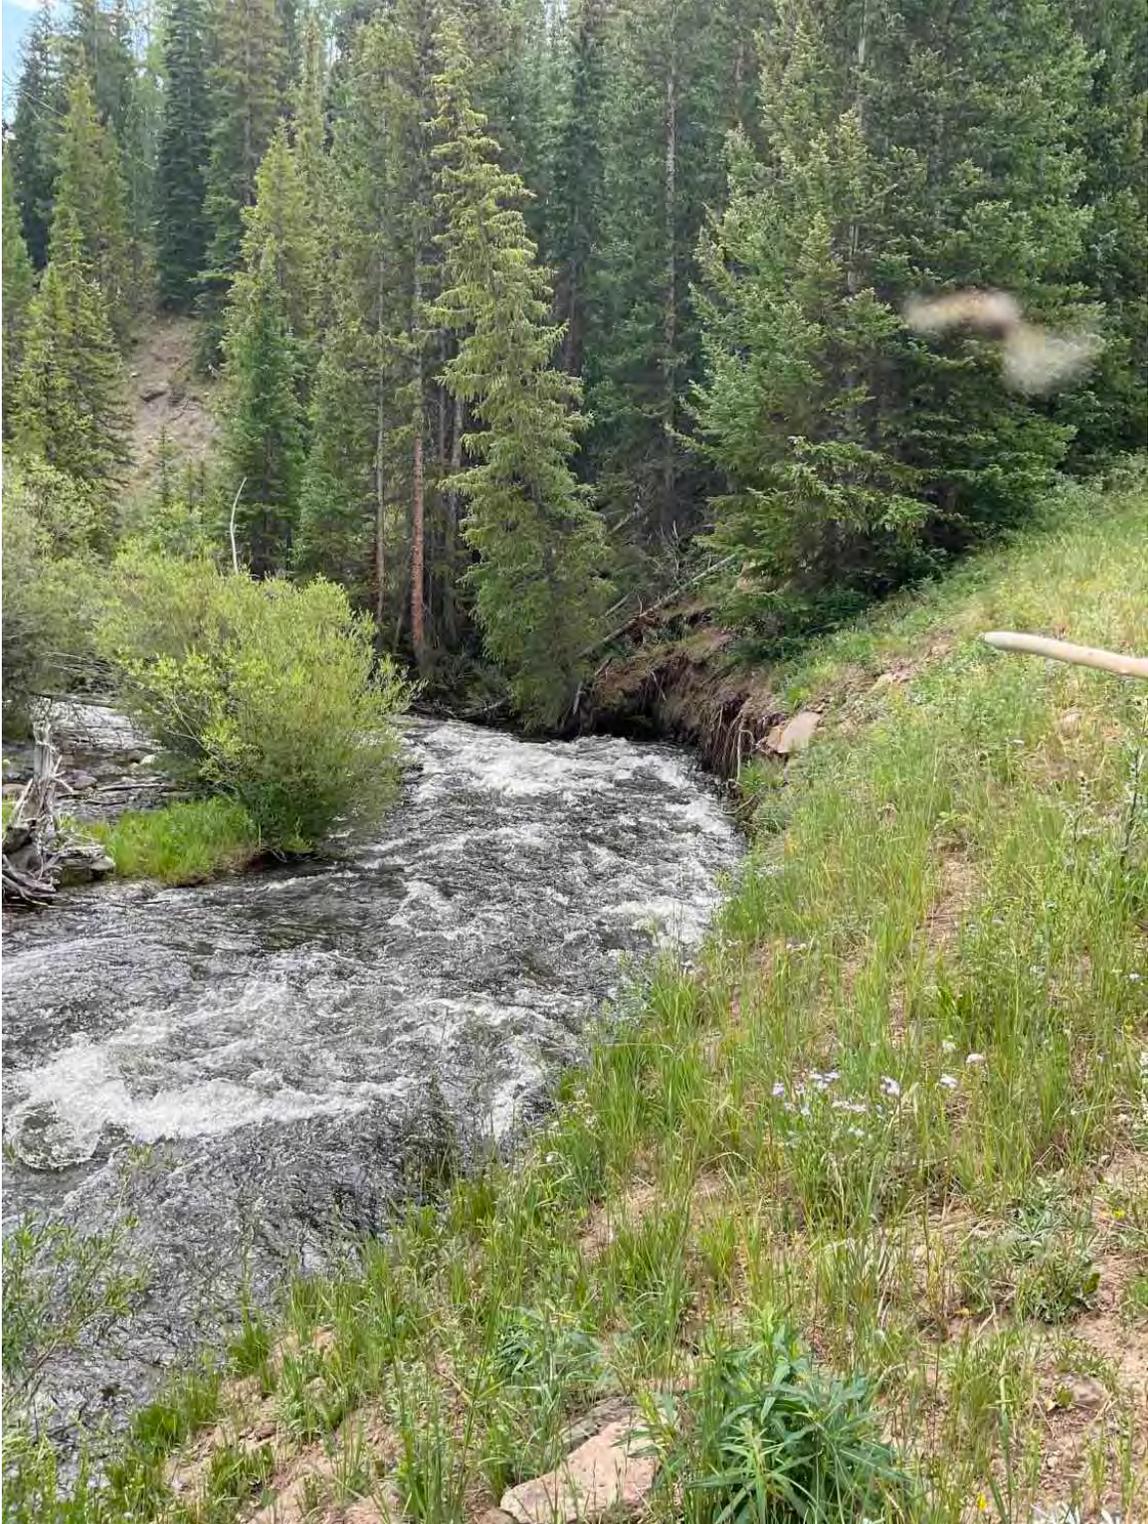
Figure A-3. Eroding bank near tributary on river left in riverscape 38.

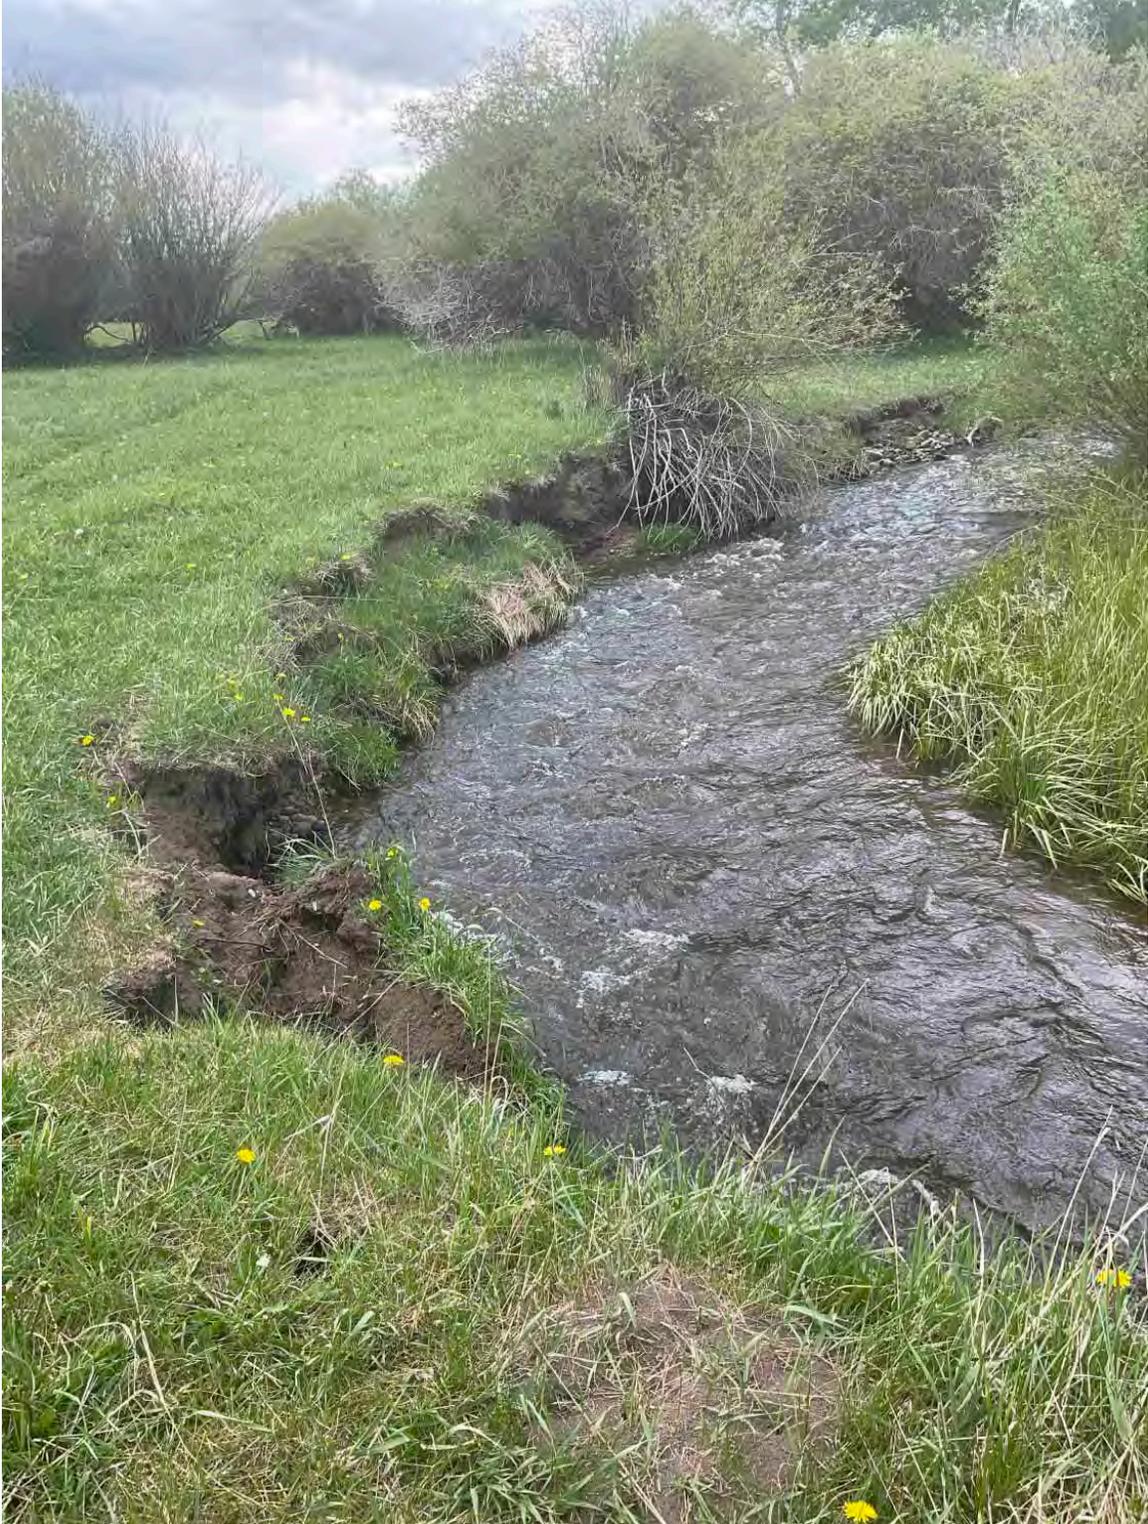
Figure A-4. Bank erosion in riverscape 1.

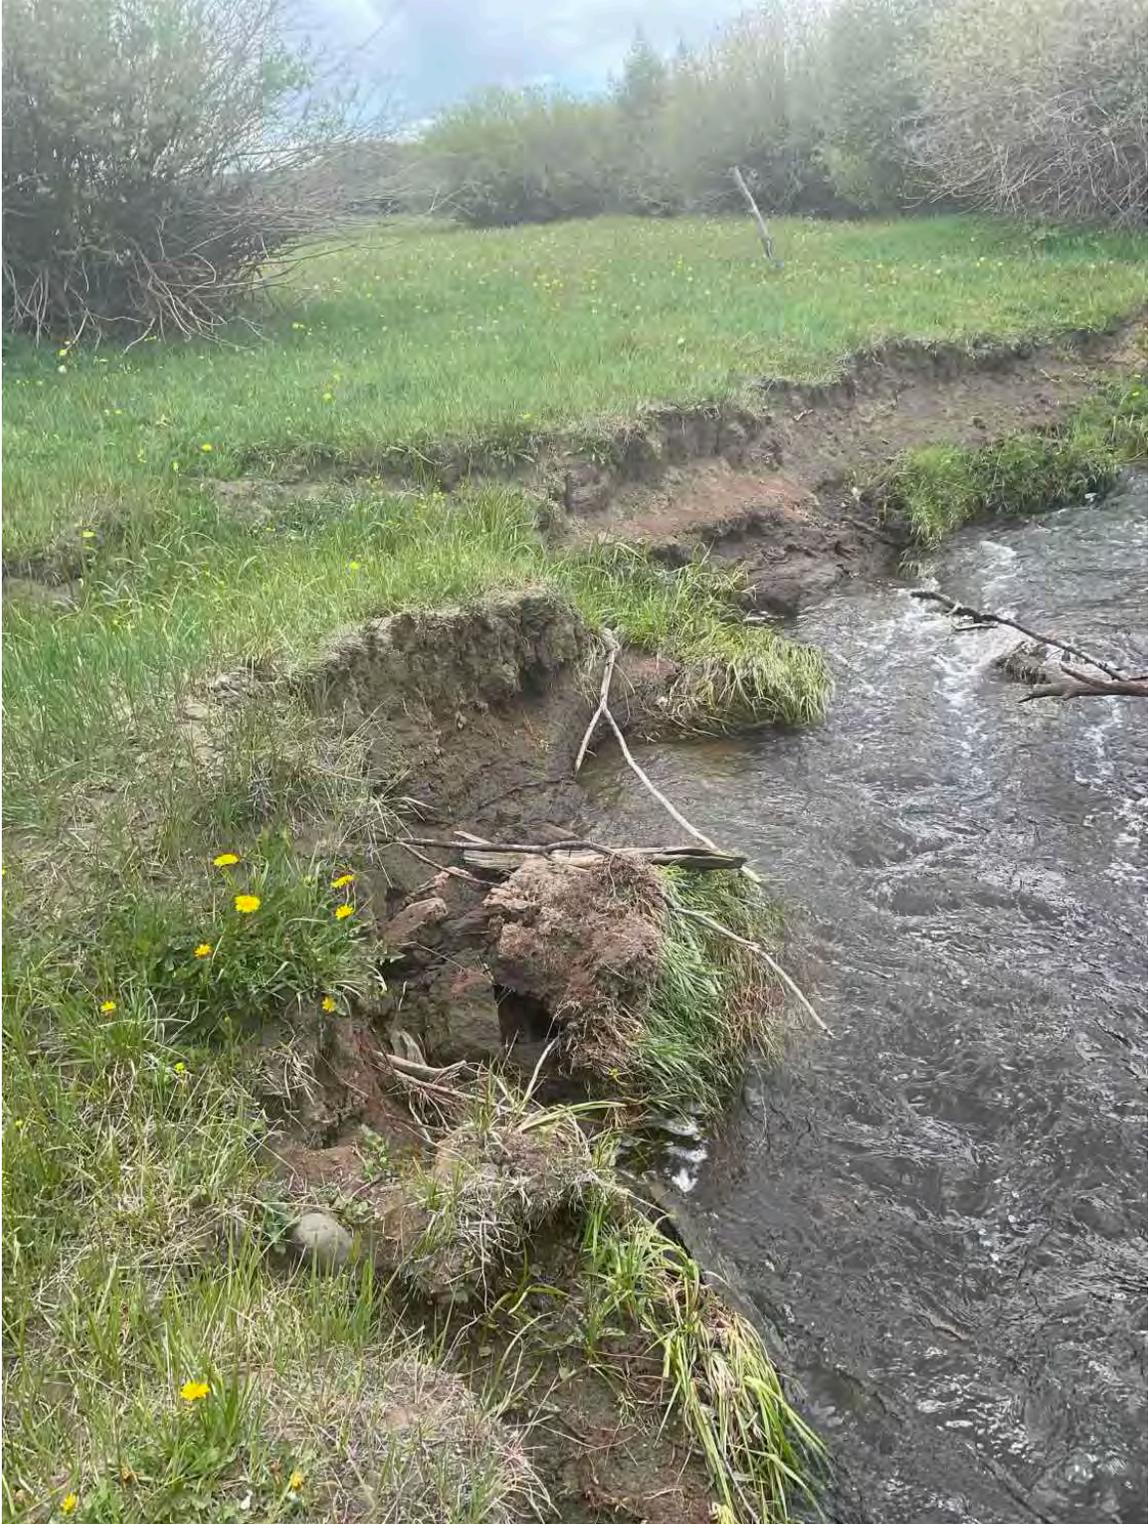
Figure A-5. Bank erosion in riverscape 1.

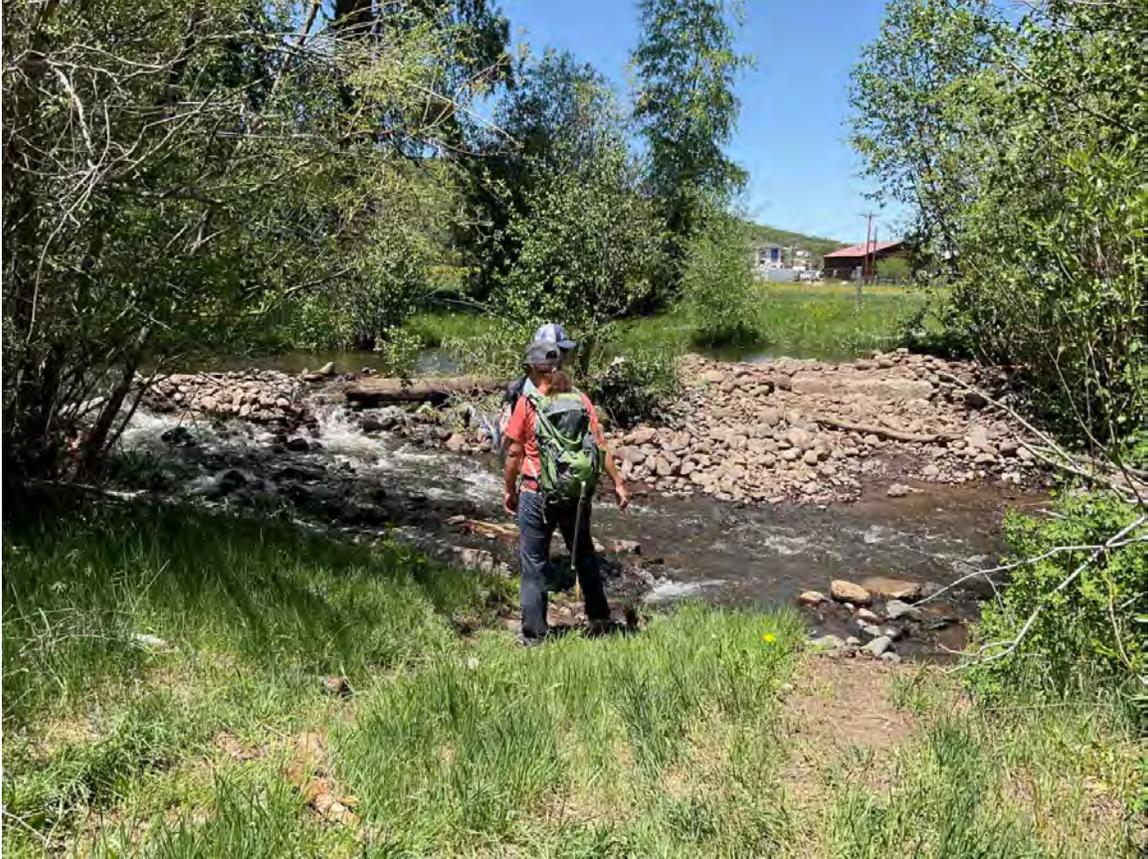
Figure A-6. Diversion structure in riverscape 1 (Nickell Ditch).

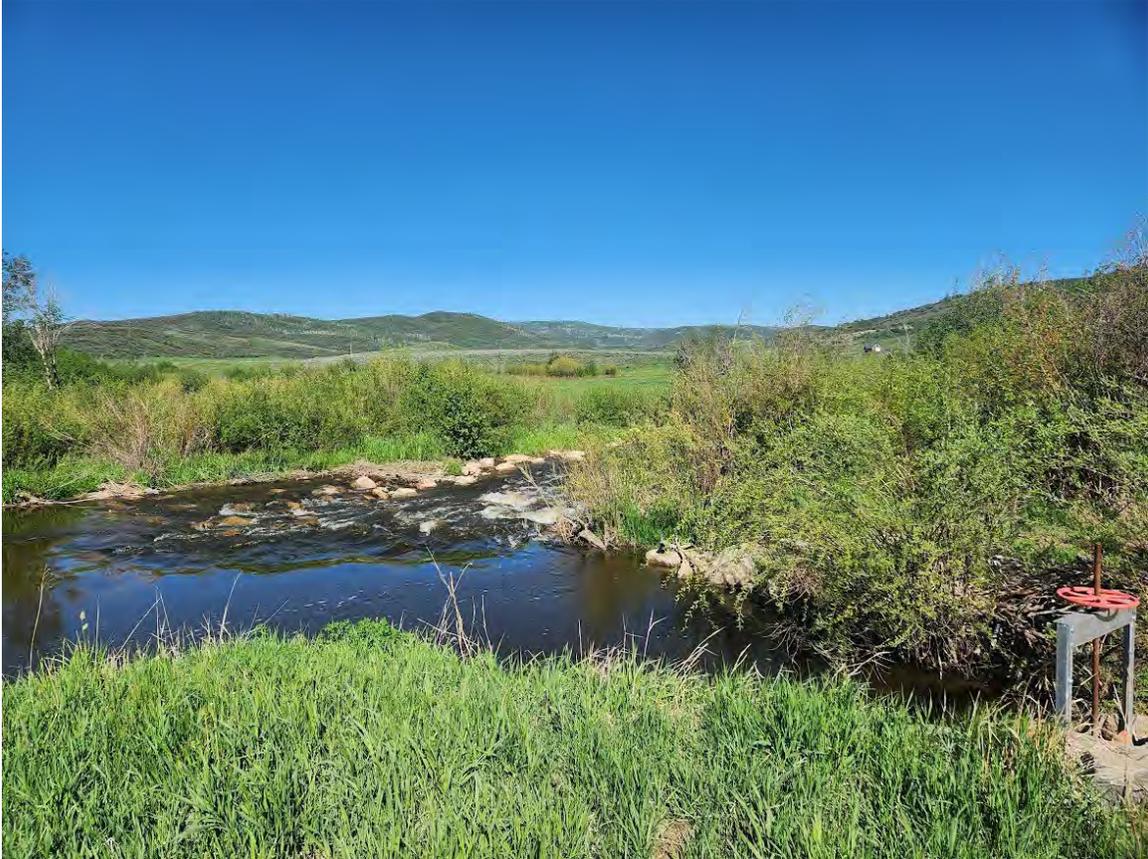
Figure A-9. Example of the recently reconstructed South Side diversion structure with a ecological rock ramp feature in riverscape 4 that allows for fish and sediment passage while ensuring the decreed amount of water to the ditch (photo from October 2023 courtesy of Flywater Inc).

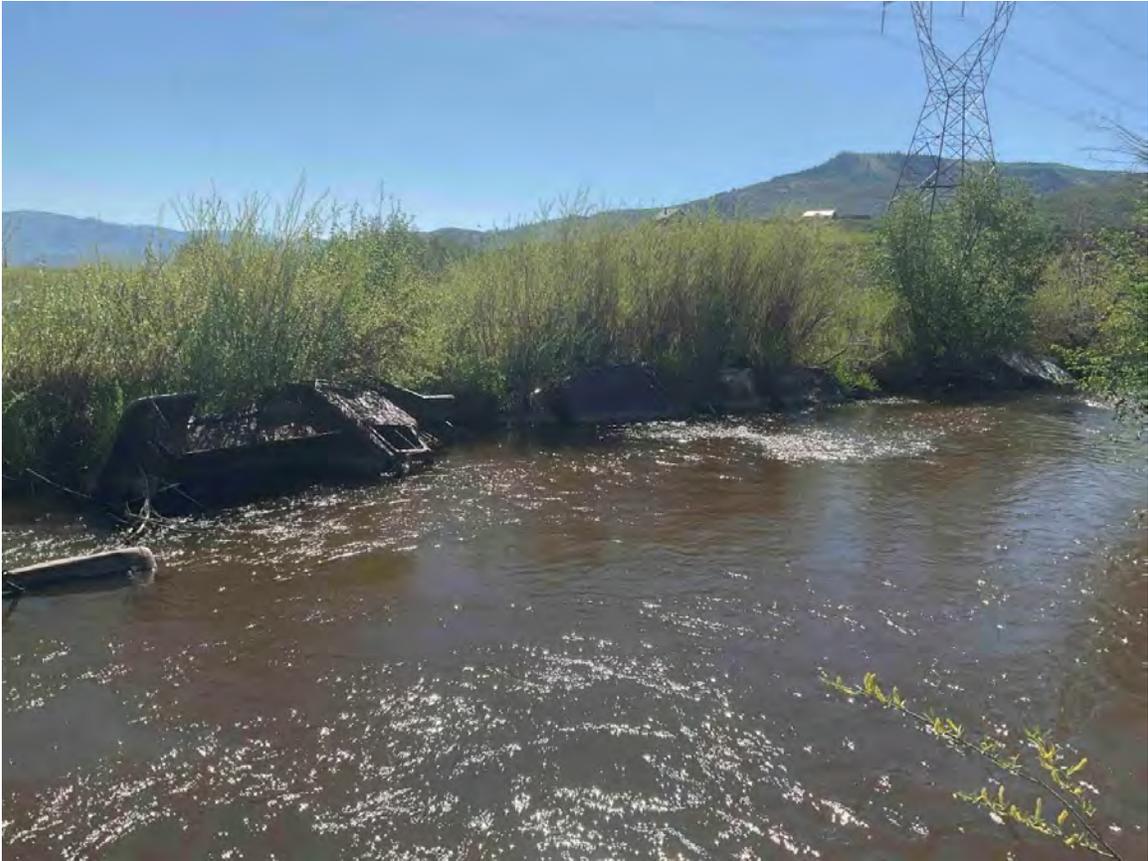
Figure A-13. Bank armoring with old automobiles in riverscape 4.
