Yampa River Scorecard Project Upper Yampa Segment Results and Scoring

March 2025

Friends of the Yampa
Steamboat Springs, Colorado

Alba Watershed Consulting
Boulder, Colorado

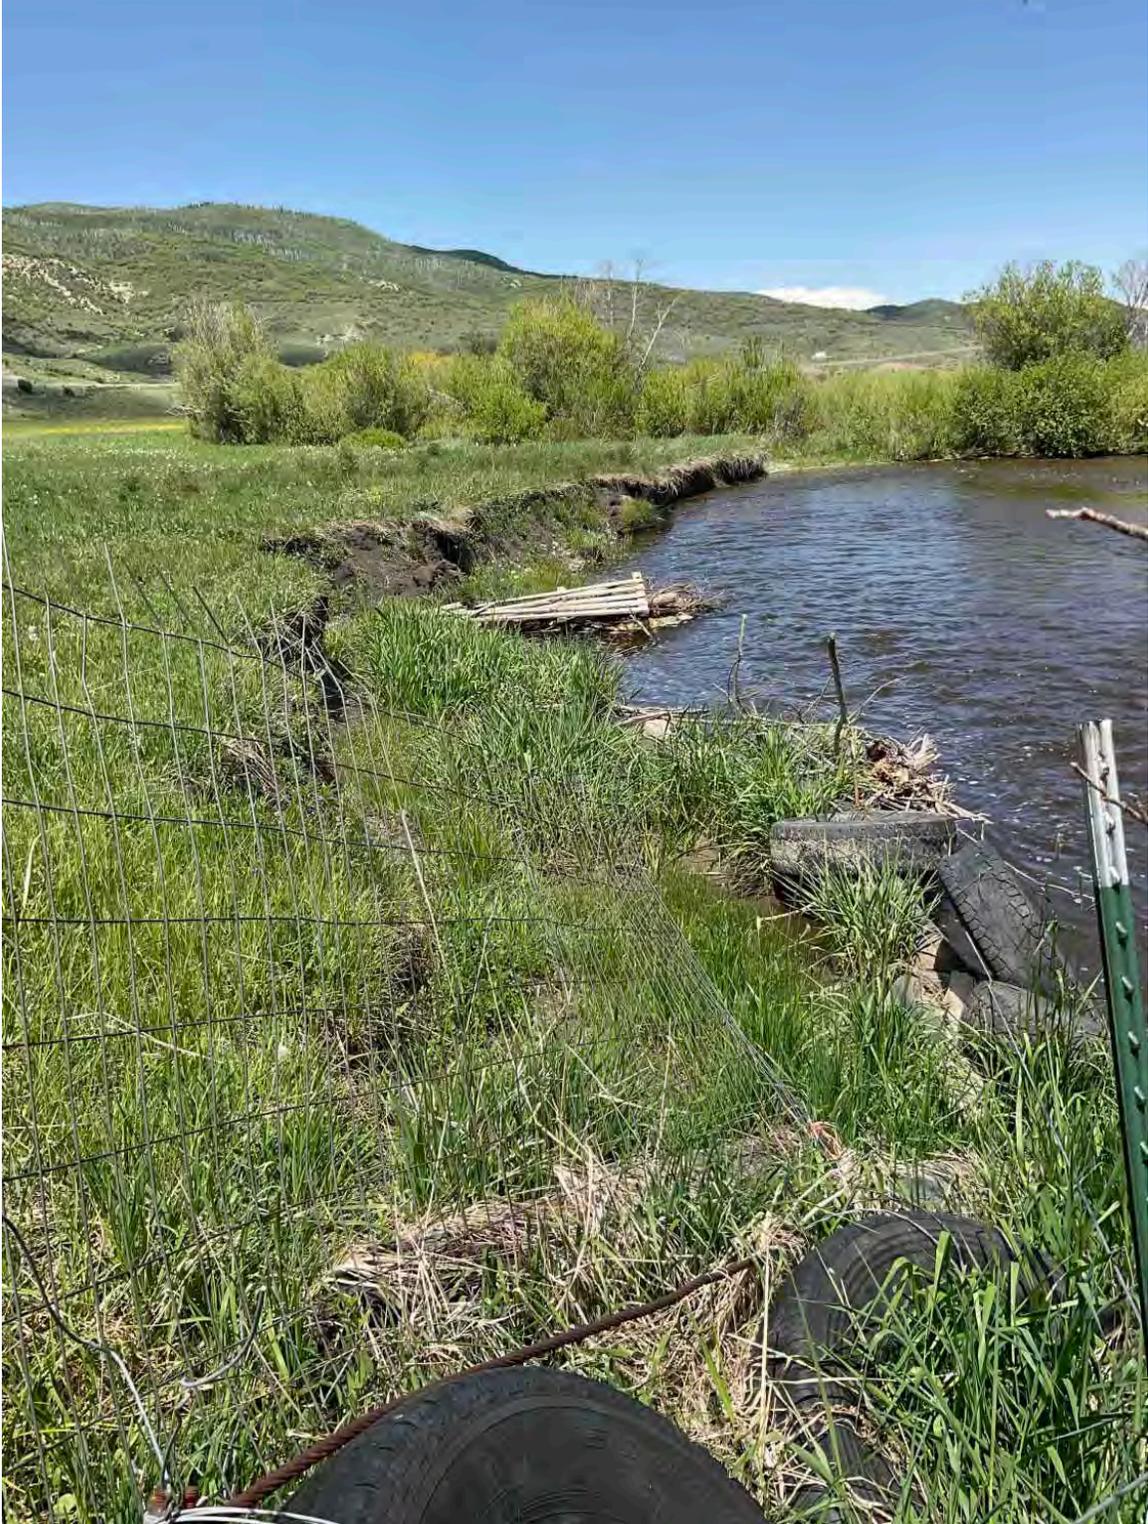
Figure A-14. Bank armoring with old tires in riverscape 4.

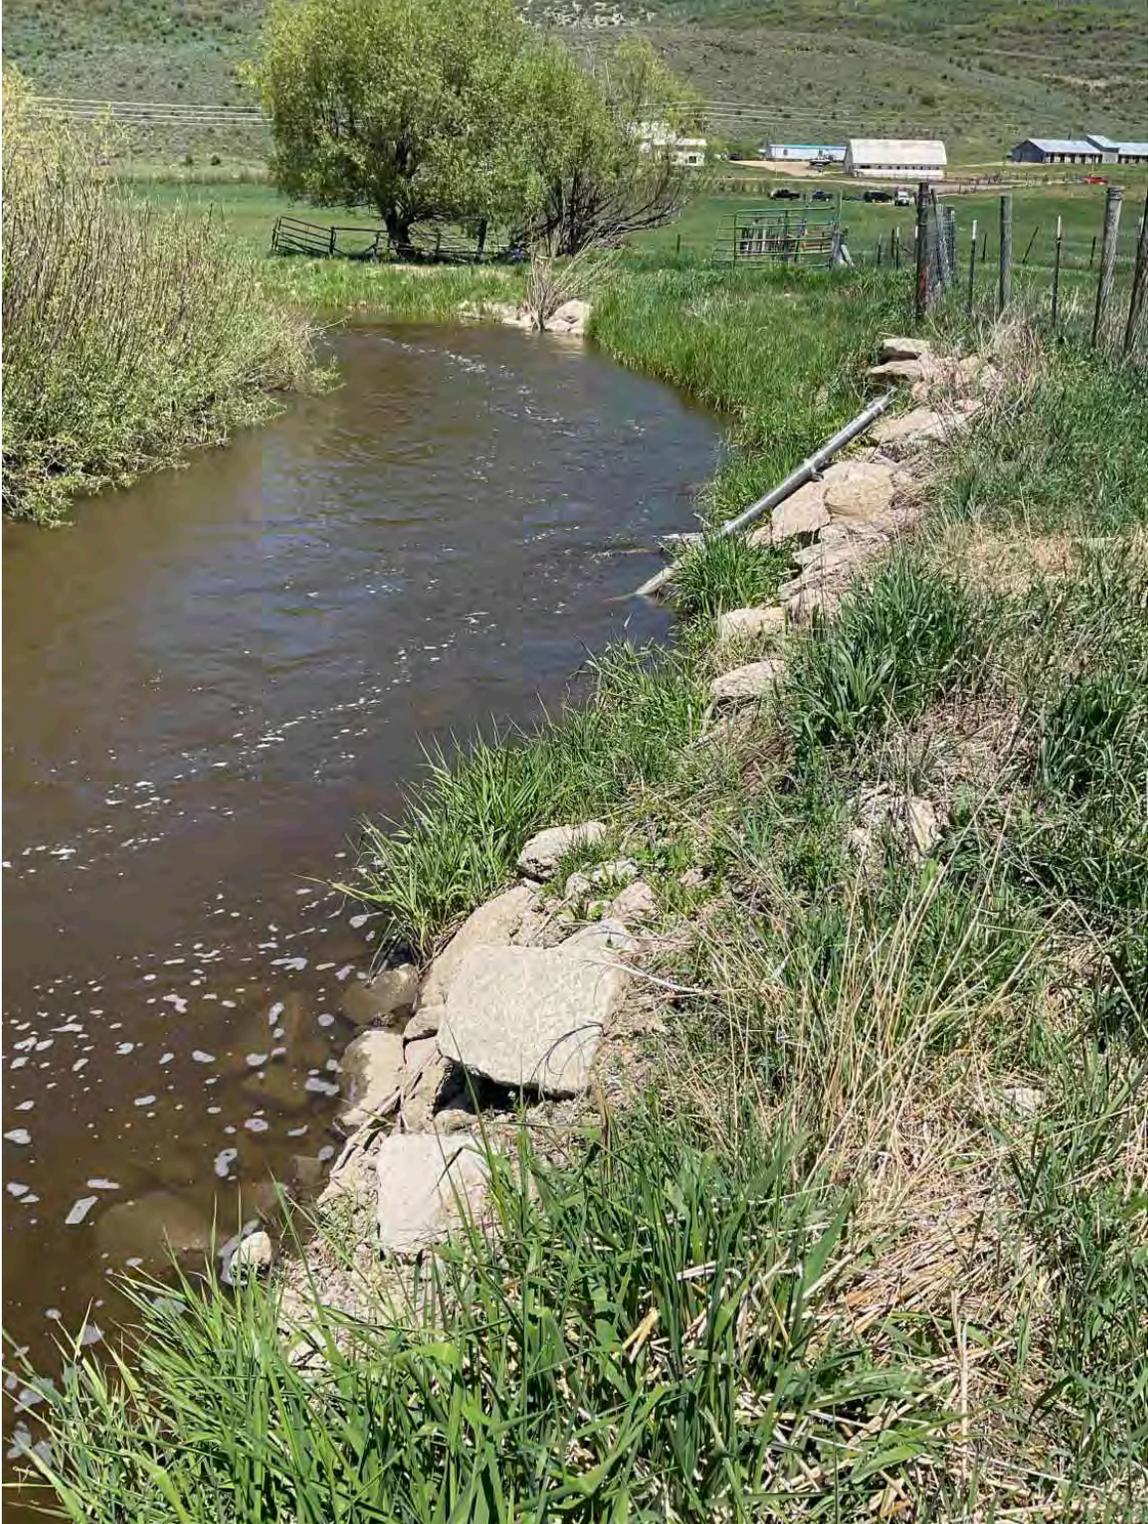
Figure A-15. Bank armoring with concrete rip rap in riverscape 4.

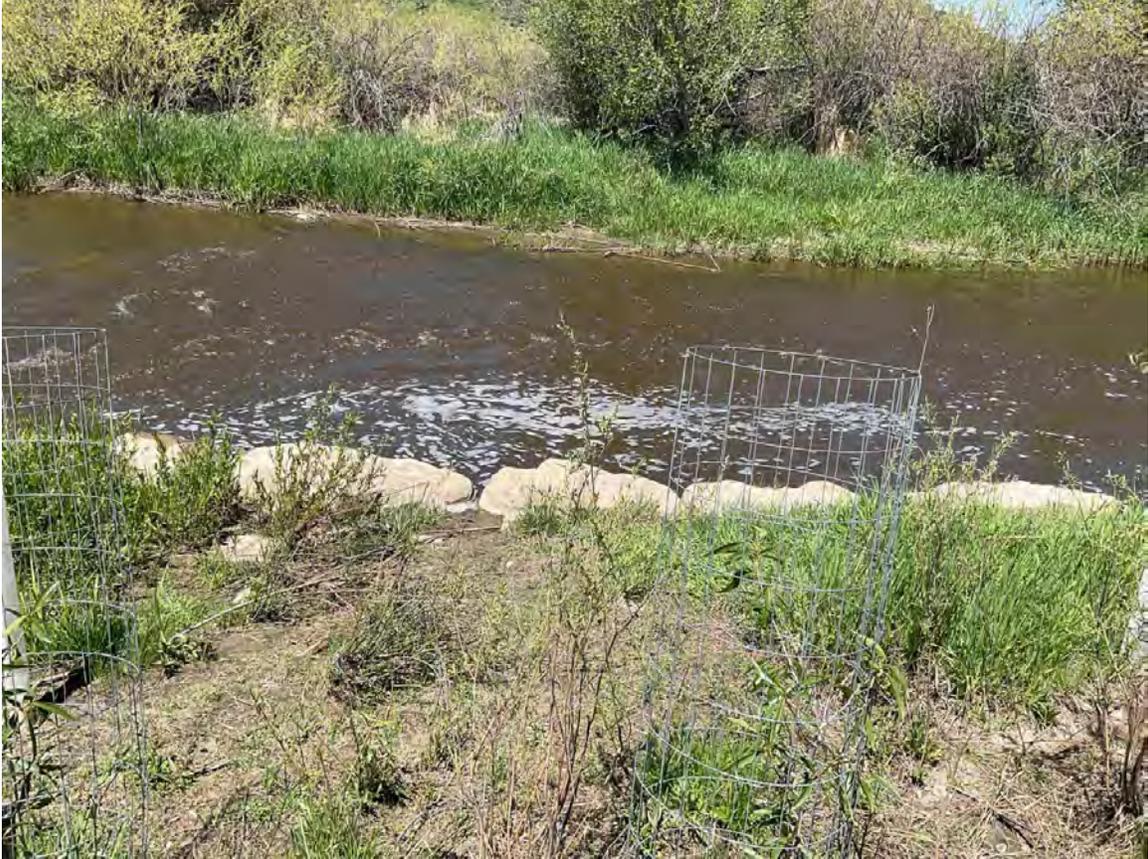
Figure A-16. Bank armoring with large boulders in riverscape 4.

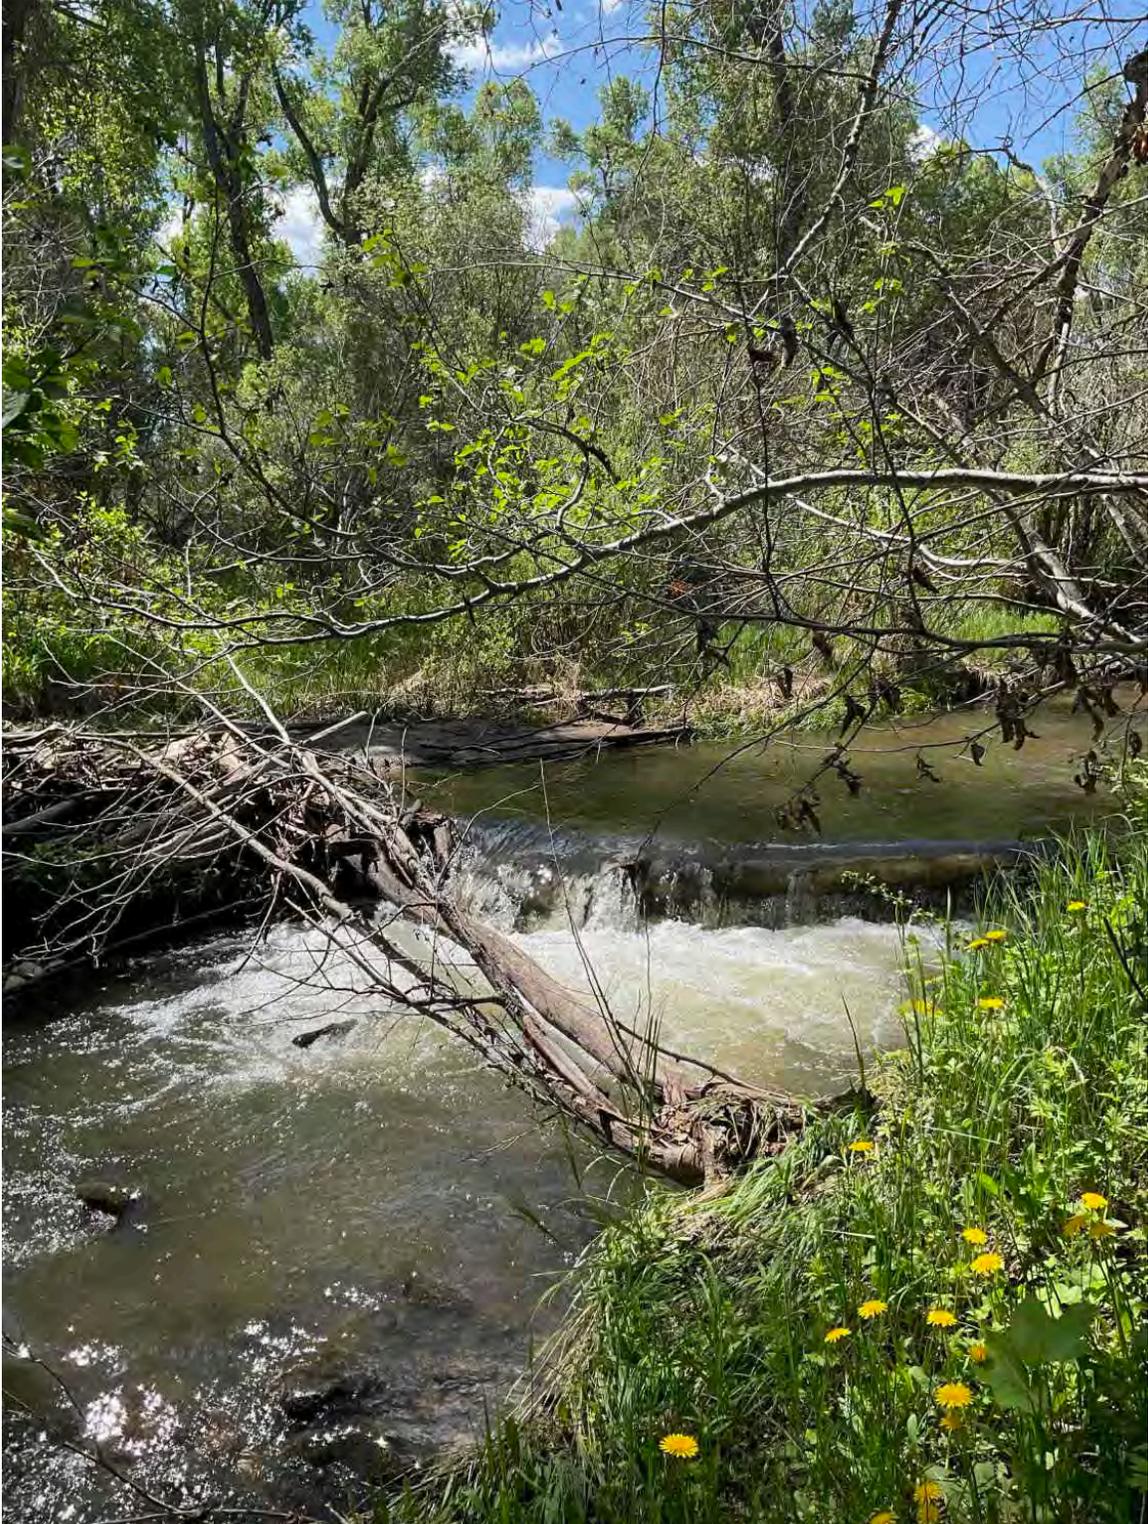
Figure A-20. Channel-spanning log jam in riverscape 1.

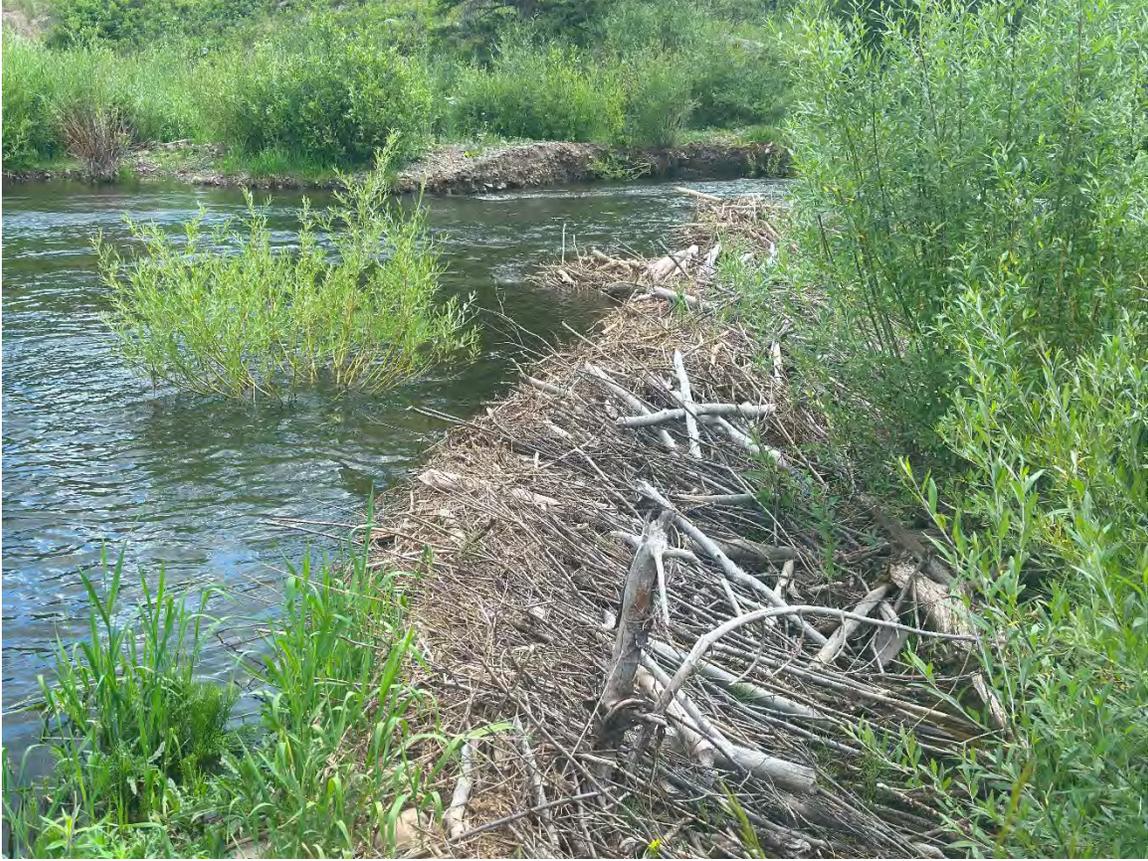
Figure A-25. Breached beaver dam in riverscape 38.
